## Thermodiagnostics of flat roofs

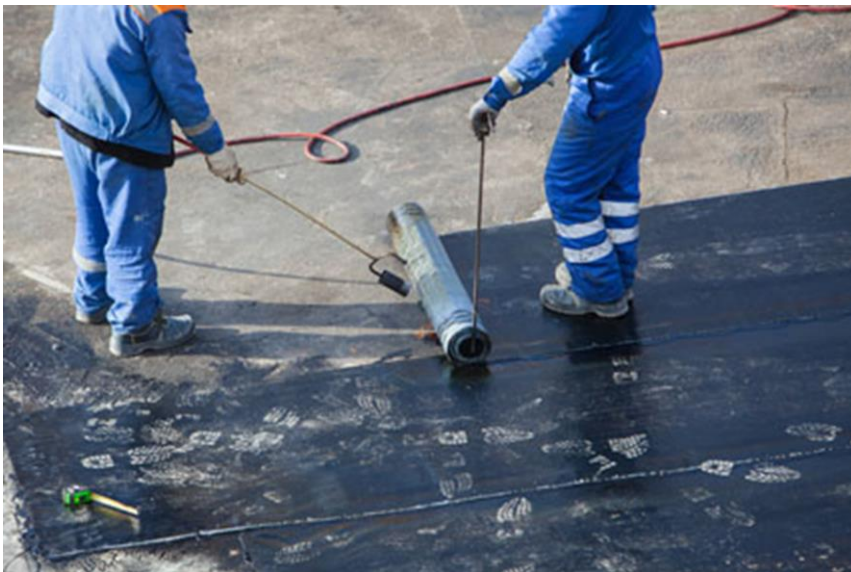
***The most frequent reason for problems with flat roofs is that thermal insulation is not self-contained and between thermal insulating layers and boards are various large gaps. Therefore, during the reconstruction of roof, the exact technological procedure must be followed.***

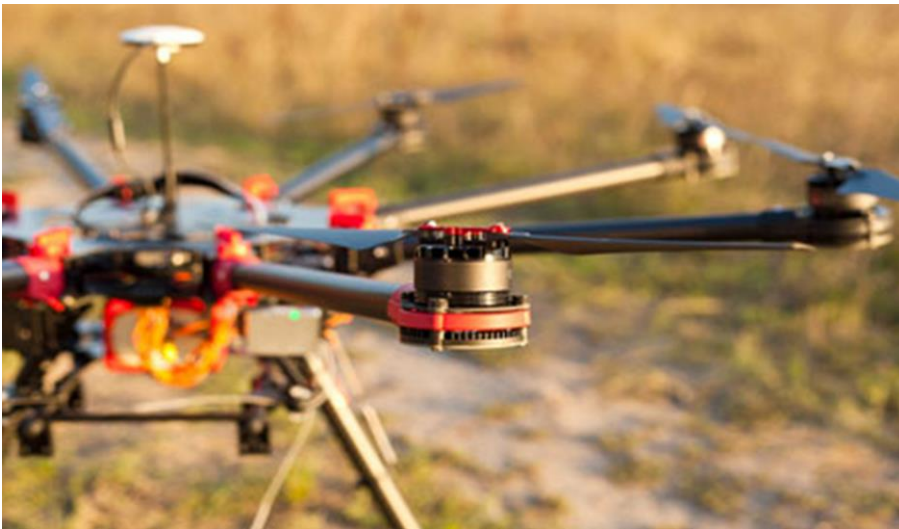
*Workswell WIRIS thermal imaging system located on the drone. The system combines a thermal imaging camera and a camera in a visible spectrum.*

The company **Workswell** developed the **Workswell WIRIS system**, which combines two camera systems - a visible spectrum camera (for inspection of visible defects found by thermal camera) and a thermal camera for detecting the problems mentioned above. **The servicing software enables to remotely switch camera regimes, to record radiometric videos or to make static images in both the visible and infra-red spectrum.** The operator sees the objects under the drone in real time or can analyse records and identify damaged areas.

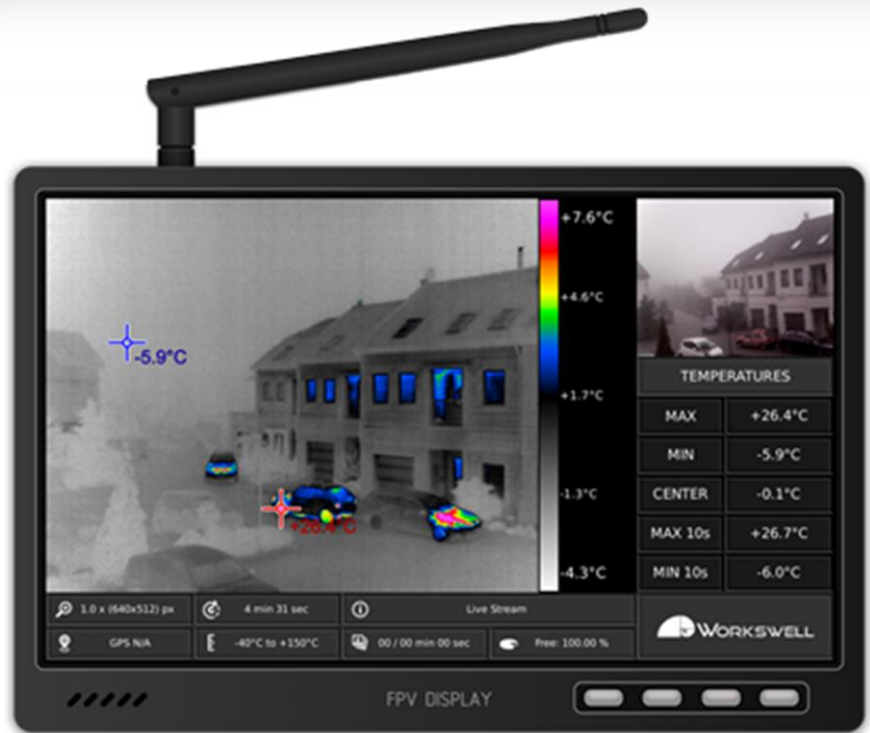
*View on the operator's screen. When in use, the Workswell WIRIS system provides the same comfort as existing manual thermal cameras. All parameters can be set for measuring, including emissivity and the reflected temperature. The high sensitivity of the system is achieved by manually setting the range of temperatures. A whole series of pallets are available and the option to measure either in the point, as well as in the local maximum and minimum. Minimum and maximum are localized by a blue (minimum) and red (maximum) cross.*

**The system can measure temperature at the central point, as well as in the local minimum and maximum.**

Minimum and maximum are localized using a blue (minimum) and red (maximum) cross. This function can also be used to navigate drones because the system automatically shows where the largest potential problem is located.
